# June 2009 Floods

## Flood Investigations Final Report

**Produced by: Streetpride Drainage Team,  
Environment & Development Services**

**Date: April 2010**

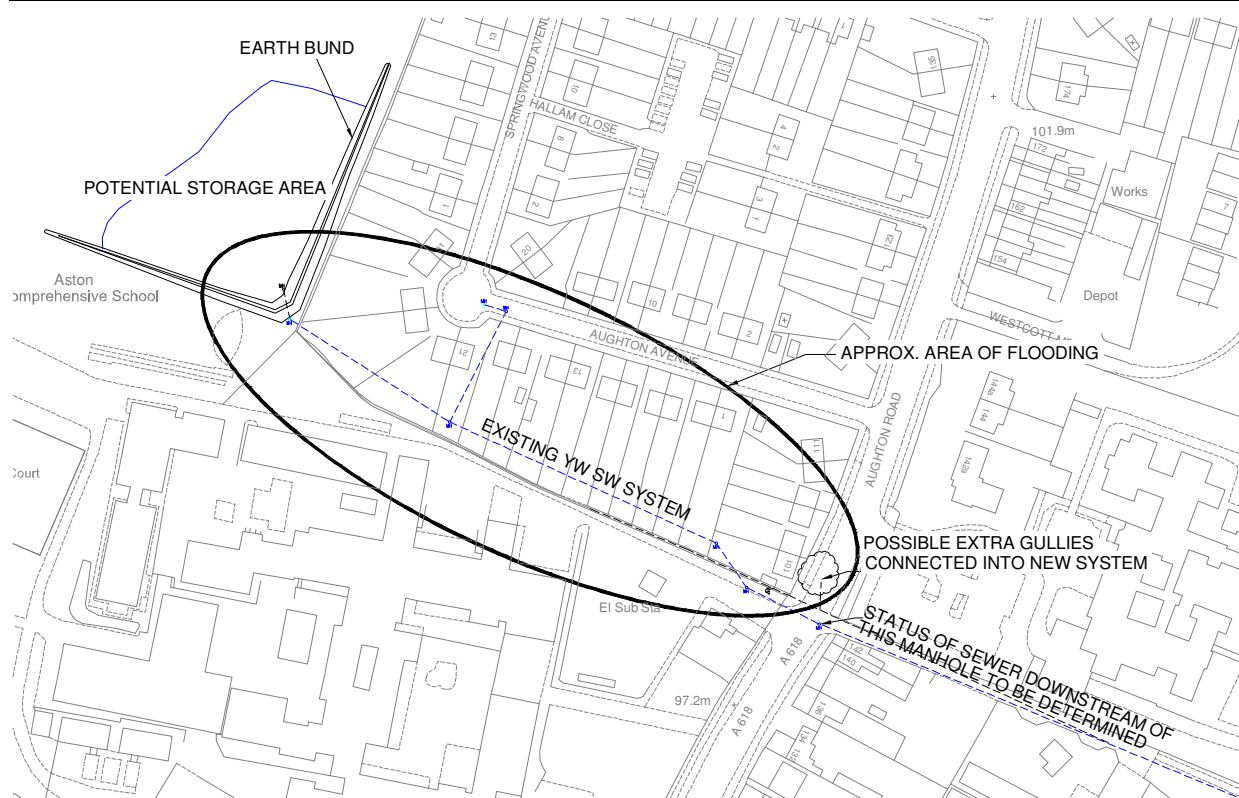
- Yorkshire Water have recorded several problems on the public combined sewers serving these properties. Most of these were caused by blockages in the sewer. These blockages were cleared by Yorkshire Water and are unrelated to the flooding incidents in this investigation.

- The houses on the west side of Aughton Road are lower than road level, and the existing surface water and combined sewers do not have sufficient capacity to allow water to drain beneath road. The road has a crossfall from east to west, causing ponding on the west side of the road, which then runs into the gardens when the level rises sufficiently.

Minimising flood risk in this area can be achieved by a combination of three strategies, minimising the flows into the area, maximising the outflows and creating areas where any difference between inflow and outflow can be accommodated without causing damage to property.

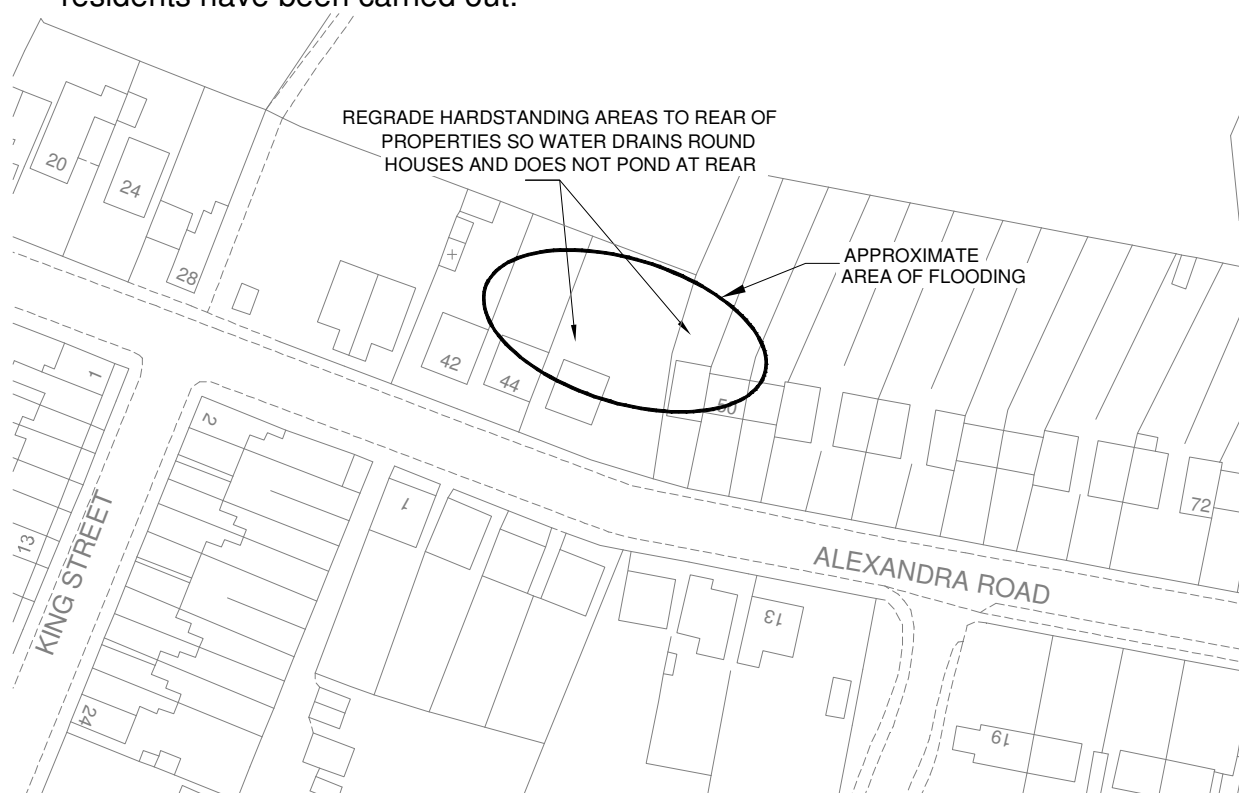
- Inspections, a survey of the existing drainage, level surveys and interviews with residents have been carried out.

At numbers 48 & 50 flooding could be prevented by re-grading their rear concreted areas to prevent any standing water being trapped. Any excess water will then run around the side of number 48 and down onto the Alexandra Road. This work is the responsibility of the property owners.

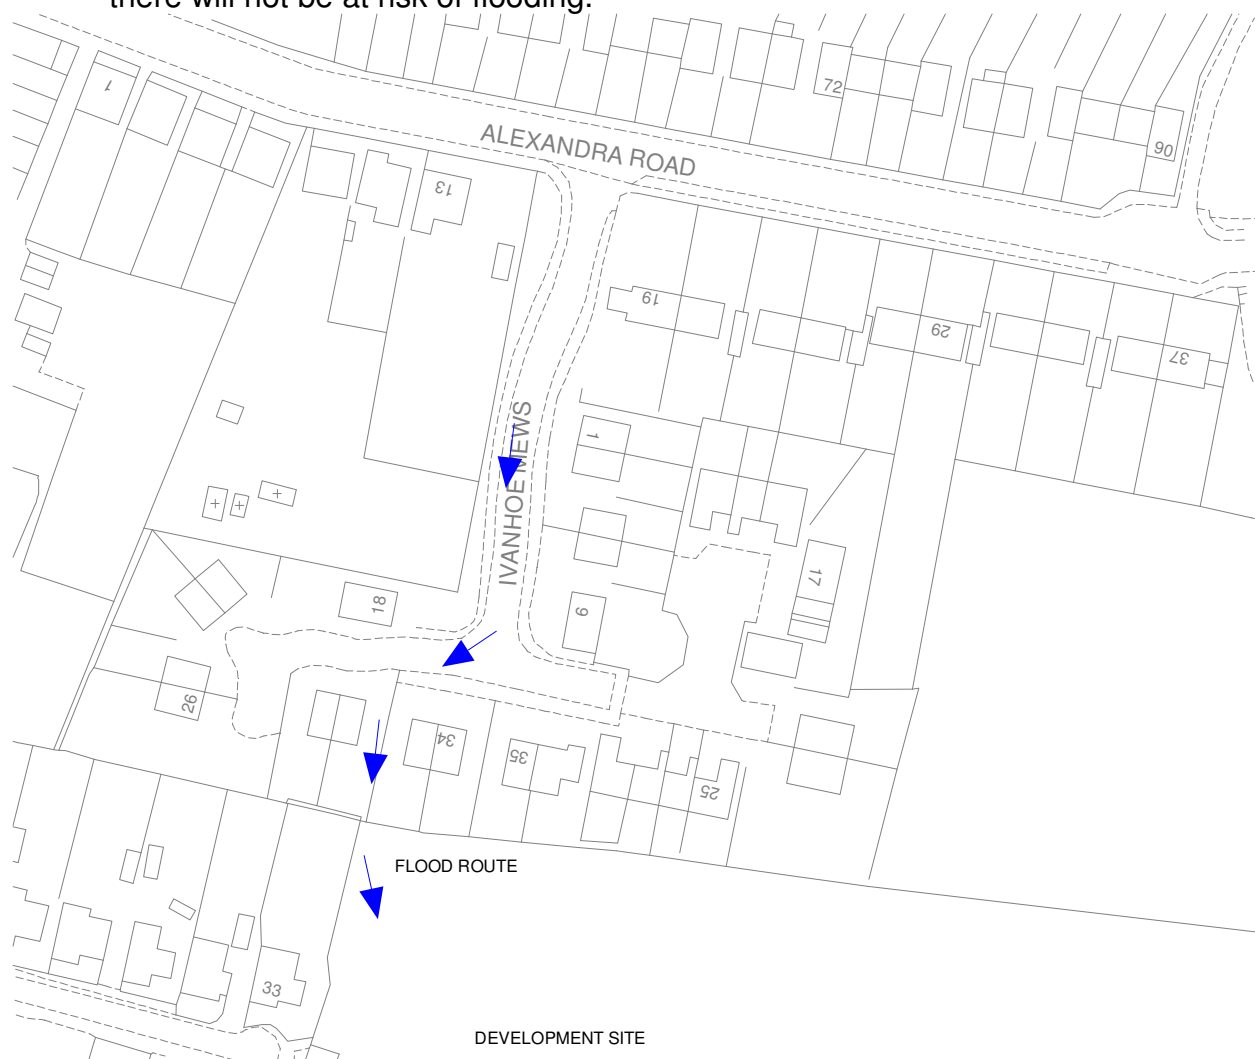
- The survey work has been completed. Inspections, a survey of the existing drainage, level surveys and interviews with residents have been carried out.
- Discussions have taken place with the developers of the adjacent site to ensure that if flood water flows from Ivanhoe Mews onto the site, the new properties there will not be at risk of flooding.

Surface water flows through these gardens only in exceptional circumstances. A flood route should be maintained by ensuring that the water can flow around the houses without obstruction.

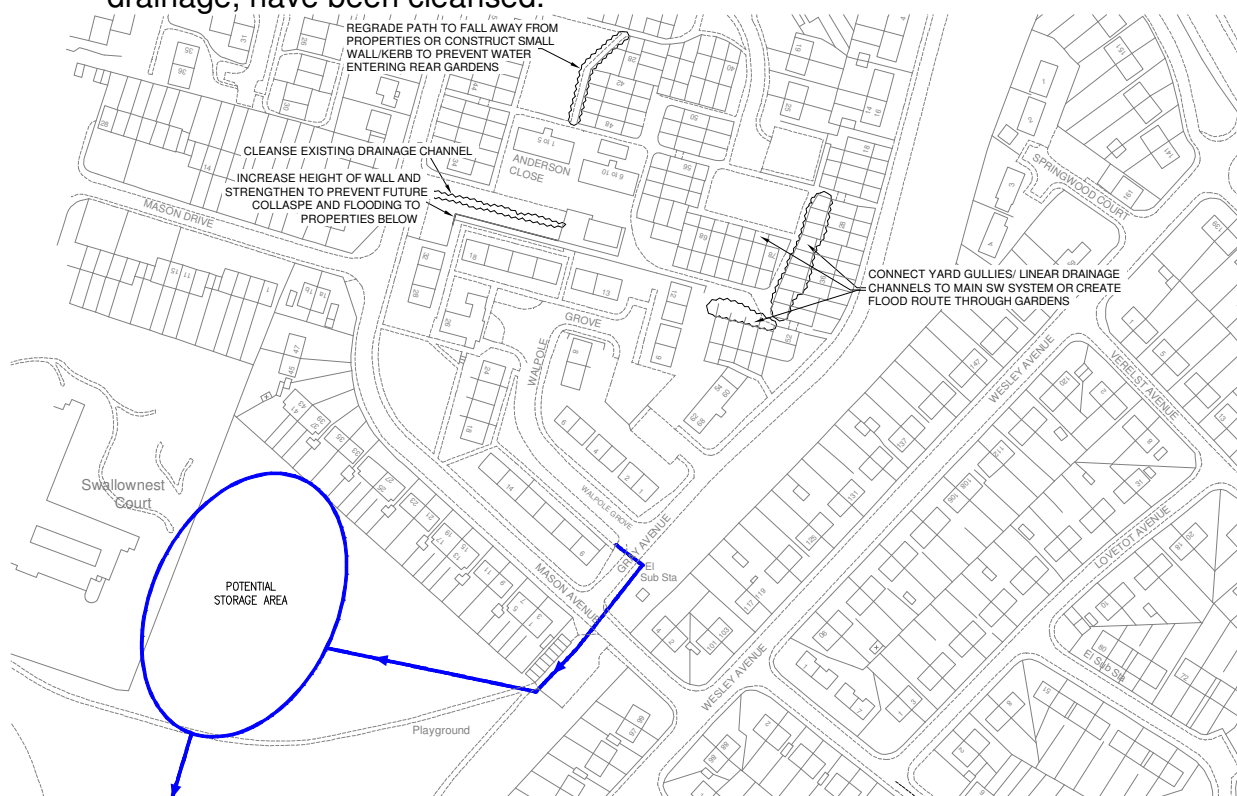
- Many gullies draining the properties are blocked and several down pipes are broken preventing water from draining into the sewers.

- Inspections, a survey of the existing drainage, level surveys and interviews with residents have been carried out.
- The condition of the drainage system in this area is poor structurally and the system was found to be blocked or partially blocked in several areas. The worst of these have now been cleared but the drains serving the parking area to the north of Walpole Grove are heavily silted.
- The foul sewers in front of Anderson Close were badly blocked and have been cleared.
- In Wharton Avenue, foul and surface water systems including the car park drainage, have been cleansed.

The defects on the existing sewers should be repaired and all the drainage in the area should be thoroughly cleansed.

A feasibility study is recommended to investigate the possibility of creating a flood storage area on the land south of Mason Avenue. A new surface water sewer would be required to intercept flows in the existing surface water sewers and transfer them to the flood storage.

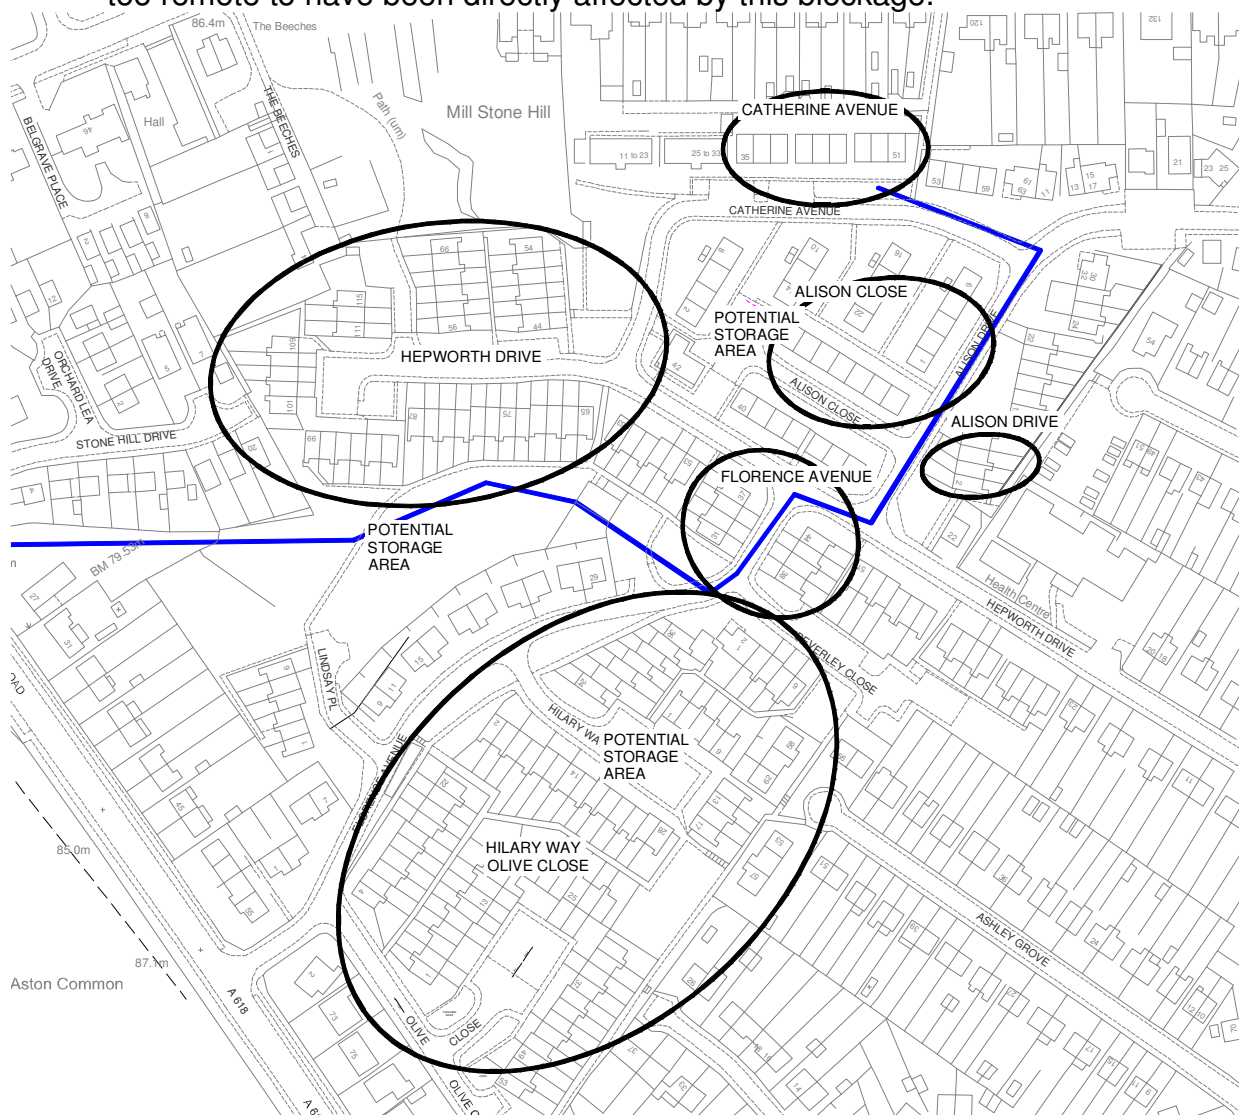
Overland flows through gardens caused the collapse of a large section of a garden wall.

- Inspections, a survey of the existing drainage, level surveys and interviews with residents have been carried out.
- The critical surface water sewers have been identified and CCTV surveys of these sewers have been completed.
- A manhole in the open land between Hepworth Drive and Florence Avenue was found to contain a large amount of debris, causing a major disruption to flows. Large items found in the manhole suggest that many items were deliberately put into the manhole. This manhole has been cleared and the system is now running freely. Most of the flooded properties drain through this manhole, but many are too remote to have been directly affected by this blockage.

Many of the blocks of properties on this estate have gardens at either the front or the rear which slope towards the dwellings. During extreme rainfall events, the drainage around the properties is inadequate. The water then starts to pond and cannot drain around the properties because outbuildings, fences or walls obstruct any possible overland drainage routes. Preventing flooding of such properties can be achieved in 2 ways, that is diverting any overland flows away from the buildings, or ensuring that there is sufficient drainage to cope with everything which drains into the gardens. Installation of new drainage would require the cooperation of all the property owners affected and in some cases would involve the removal or alteration of outbuildings, fences or walls. Minor improvements to some gardens at modest cost could reduce flood risk for some of the properties.

To avoid transferring flooding downstream, storage tanks would be required to attenuate the additional flows being passed forward. Because much of the flooding in that area was caused by water flowing through properties or water standing only to a shallow depth, the additional flows are relatively small. Further work is recommended to carry out the design of the proposed works and investigate the possibility of creating flood routes and/or storage areas within the Hepworth Drive area or creating storage on Aston Common, which would require the cooperation of the land owner(s). Several possible schemes have been identified, but accurate costing cannot be produced until the designs have been substantially completed.

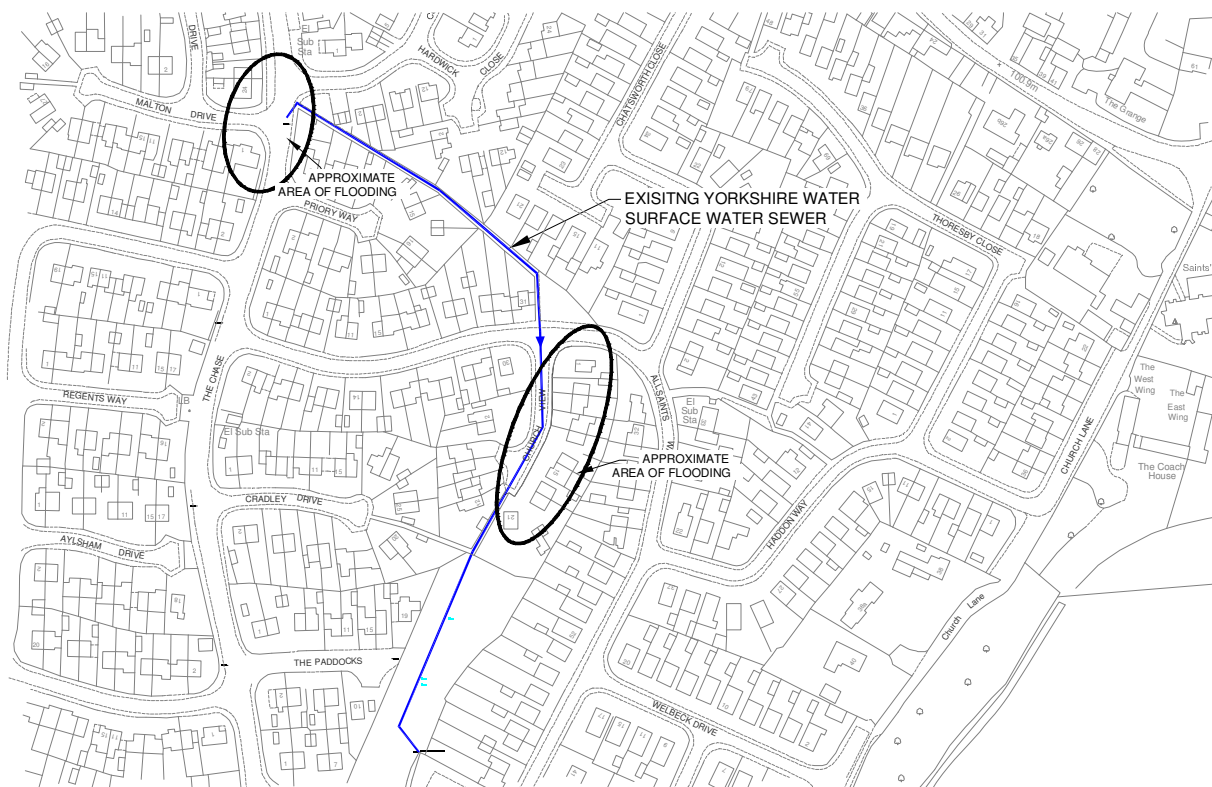
- Inspections, a survey of the existing drainage, level surveys and interviews with residents have been carried out.
- The route of the watercourse from the north side of Worksop Road, beneath the road towards The Chase is not known, but it is thought to connect to the public surface water sewer system. CCTV surveys have been completed and found several incidents of partial collapse or notable degradation of the system. Upstream of Malton Drive, a branch of the sewer system was blocked with roots so the CCTV survey could not be completed.

- This area is among those where it has been determined that the public sewers are fundamental to the effectiveness of the drainage system. Yorkshire Water have carried out their own surveys of the foul sewer and have found that the sewers are generally in good condition. However a drain rod was located in the sewer on Malton Drive and dropped pipe was identified on Cotswold Drive.

The surface water sewer which runs from the Chase to Church View then through Lineal Park has a number of defects which restrict its capacity. Even if it was in perfect condition, the sewer would not have sufficient capacity to prevent future flooding at the Chase and hence overland flows.

Possible solutions for this area involve either preventing surface flooding from occurring by increasing the size of the existing drainage system, constructing additional drainage systems, creating storage for the flood water or reducing the impact of surface water flooding by providing property level flood protection and using flood resilient construction.

Constructing a new sewer along The Chase is unlikely to be carried out due to the length of sewer required and the depth which would exceed 8m. Replacement of the sewer on the existing line with a larger sewer appears to be the best solution, but this sewer is the responsibility of Yorkshire Water. The results of this investigation have been passed to Yorkshire Water for their consideration.

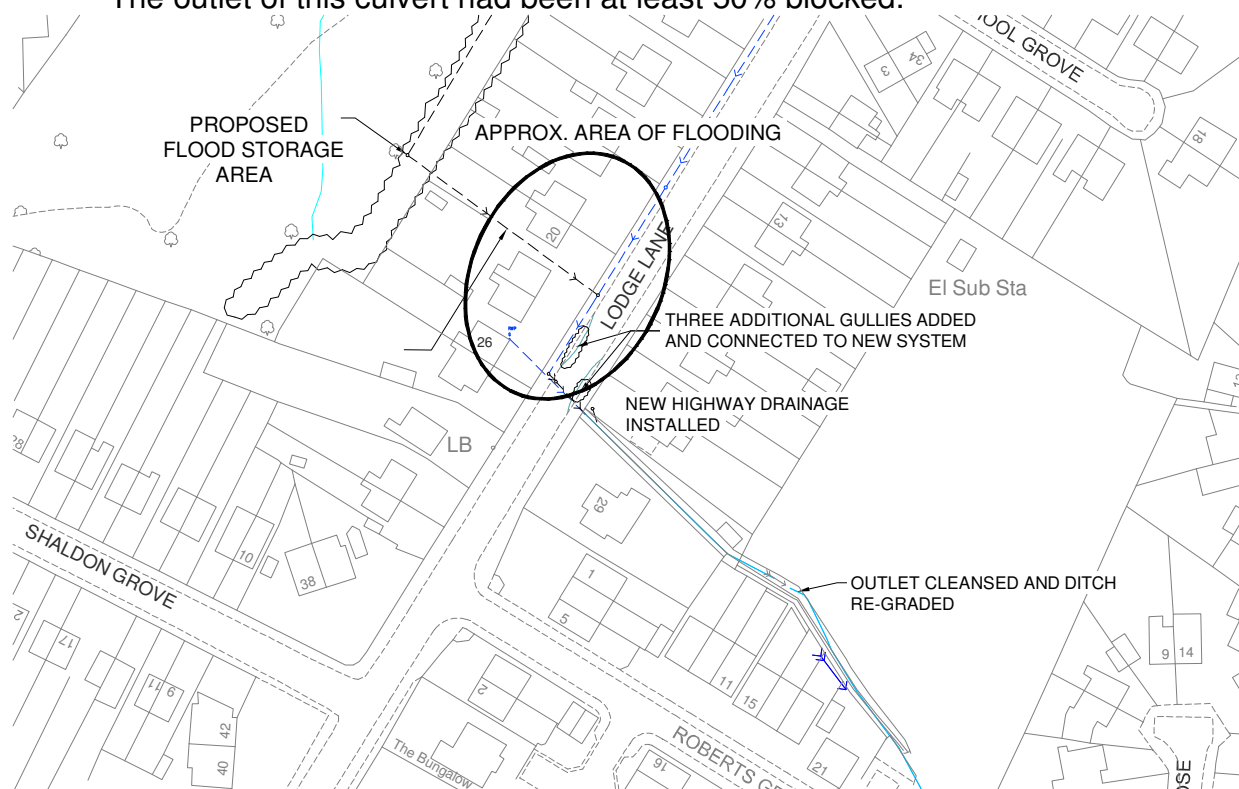
- Additional cleansing of road gullies was carried out shortly after the storm
- A detailed topographical survey has been completed.
- A CCTV survey and probing of the uncharted pipe, to establish its condition and route has been undertaken. The pipe was found to be in good condition and led to what appeared to be a buried inspection chamber in the front garden of 26 Lodge Lane. Subsequent excavations by the property owner proved that the down-pipe from the property, a land drain and the private pipe which crosses the road all converged at this point, but there was no chamber present and no evidence that any sort of inspection chamber or manhole had ever existed at that location. An inspection chamber has now been constructed and all the above pipes have been connected to it.

- Dye testing has been carried out to establish the efficiency of the gully network along Lodge Lane, which was found to be in good working order.
- The gullies along the even side of Lodge Lane have been flushed and cleansed.

- The downstream catchments have been investigated to establish any influence on Lodge Lane.
- The gully outside number 26 Lodge Lane was lowered to improve drainage of the highway locally.
- A CCTV survey of the existing 225mm diameter highway drainage system under the footway (from the manhole outside 30 Lodge Lane upstream (i.e. towards Worksop Road)) revealed no blockages in the system. There was a small amount of silt in the pipe (approximately 10% of the cross-sectional area of the pipe) which was removed from the highway drainage system (between 2 and 40 Lodge Lane) in December 2009.
- The culvert between 27 & 29 Lodge Lane and the open watercourse downstream in the land to the rear of 7 - 23 Roberts Grove has been cleared. The outlet of this culvert had been at least 50% blocked.

A temporary solution has been implemented to help alleviate the flooding on Lodge Lane. This consists of:

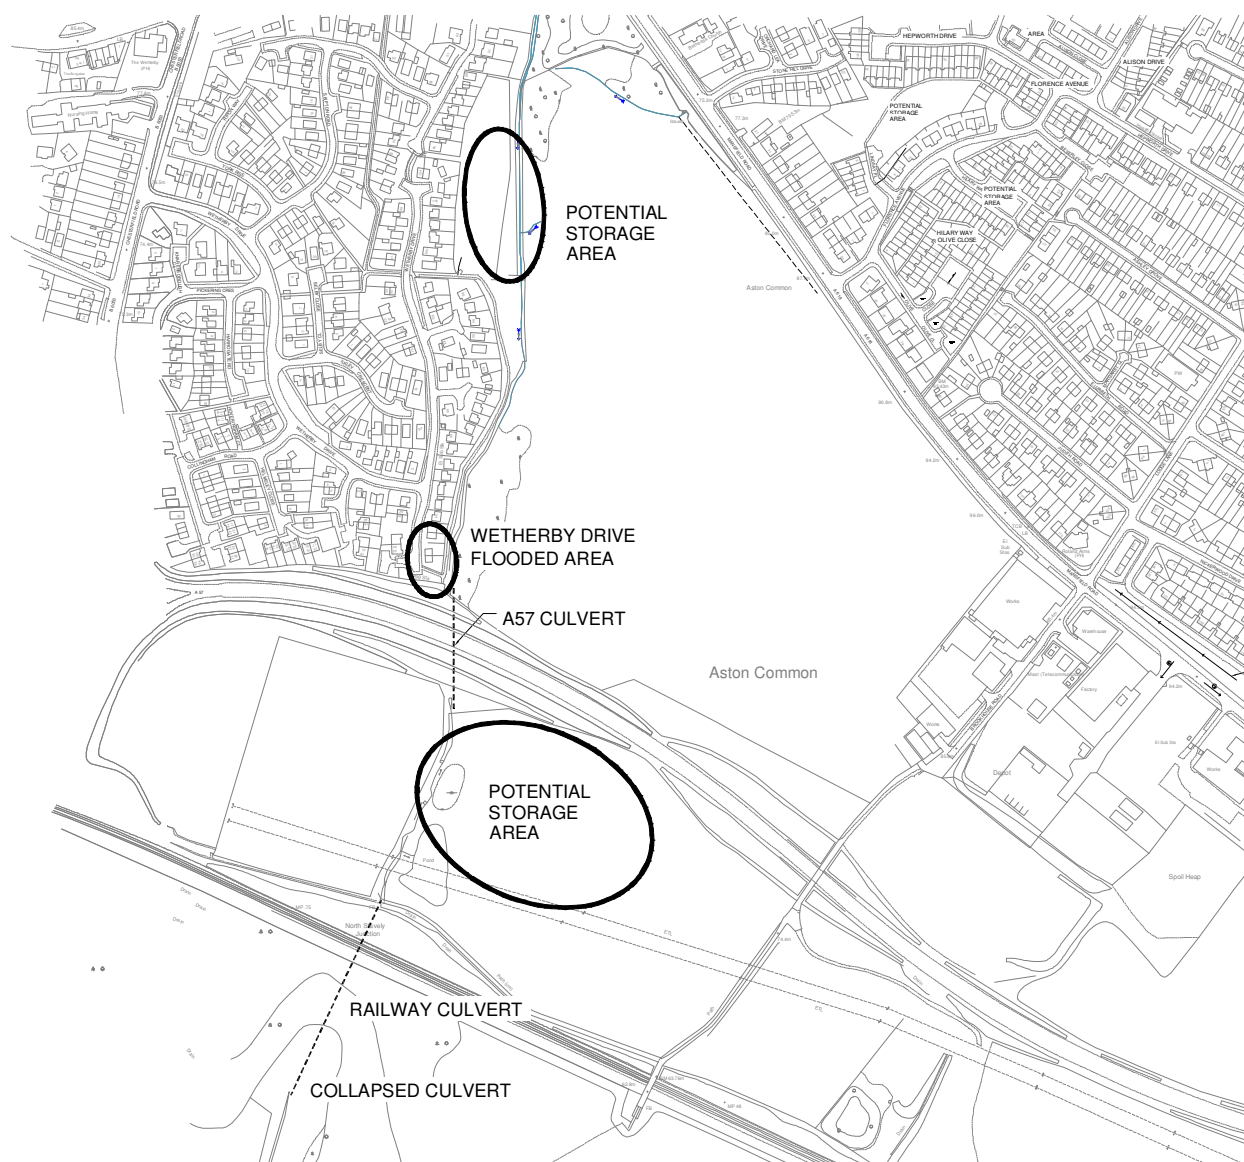
A watercourse runs in a deep cut to the east of Wetherby Drive. It flows into a culvert under the A57 Aston Relief Road. This culvert is a 94m long, bitumen lined corrugated steel culvert with a diameter of 1100mm. The downstream half of the culvert has been relined and has a diameter of 900mm. The culvert discharges to an open watercourse to the south which then enters another culvert beneath the railway line which extends into Rother Valley Country Park. This culvert is some 165m in length with no obvious access points. There is a landslip downstream of the railway caused by water escaping through defects in the culvert which is blocked and/or collapsed near the downstream end.

Both culverts had an effect on the flooding of Wetherby Drive. The restriction to flow caused by the culvert beneath the railway caused water to stand above the outfall of the A57 culvert. This would have reduced the effective capacity of the culvert.

If both culverts had been clear, with free outfall, flooding would still have occurred on 10 June, but the peak level would have been lower.

The downstream watercourse in Rother Valley Country Park should be cleared to restore a clear outfall for the culvert. This involves removing a depth of up to 2m of silt across the width of the watercourse for a length in excess of 100m.
