**A Structural Assessment Of
The Non-Traditional Tarran Houses
Owned By Rotherham Metropolitan Borough Council
In Maltby, Rotherham**

**Rotherham Metropolitan Borough Council
Civic Building
Walker Place
Rotherham
S65 1UF**

**Curtins Consulting Engineers
5 Woodside Mews
Clayton Wood Close
North Leeds Ring Road
Leeds
LS16 6QE**

**28560/NP
December 2004**

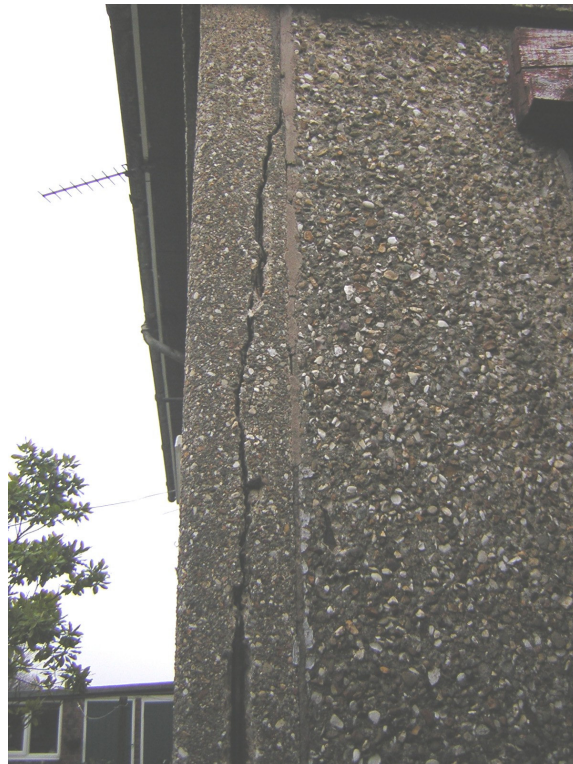
These investigations indicate that the properties have remained in a safe structural condition to date. Evidence of concrete spalling and reinforcement corrosion is apparent to some corner posts and wall panels. This is considered to be attributable to a combination of the reinforcement being displaced or poorly placed during the original construction and variability of the concrete mix.

Photograph 2 – Vertical Cracking Of Corner Post

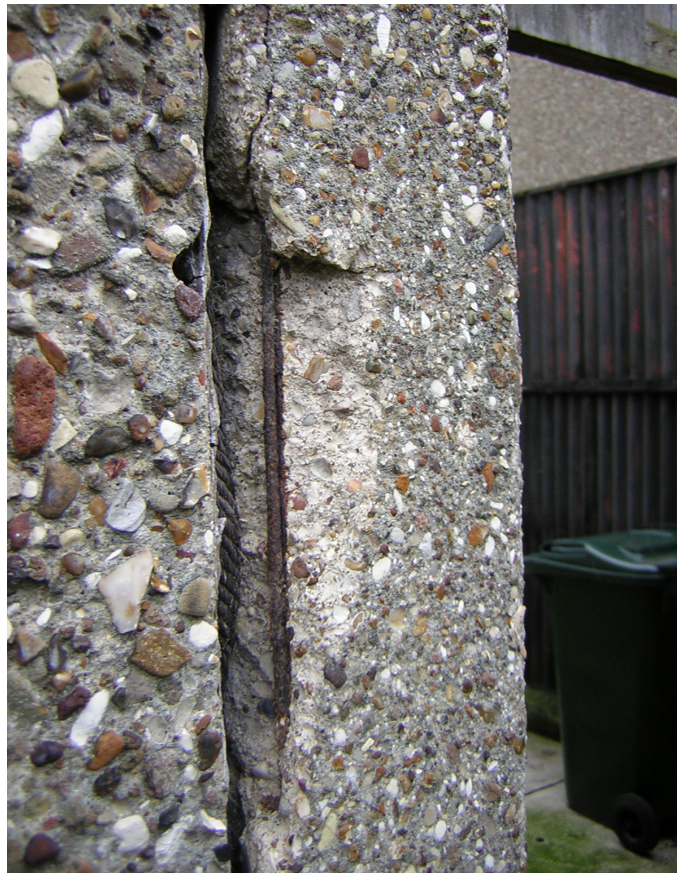
On the basis of the above, it is considered that deterioration of the concrete frame is attributable to a combination of the reinforcement being displaced or poorly placed during the original construction and variability of the concrete mix. As a consequence of the reduction in the alkalinity of the concrete through carbonation, corrosion of the embedded reinforcement has begun.

Photograph 3 – Spalling Of Corner Post

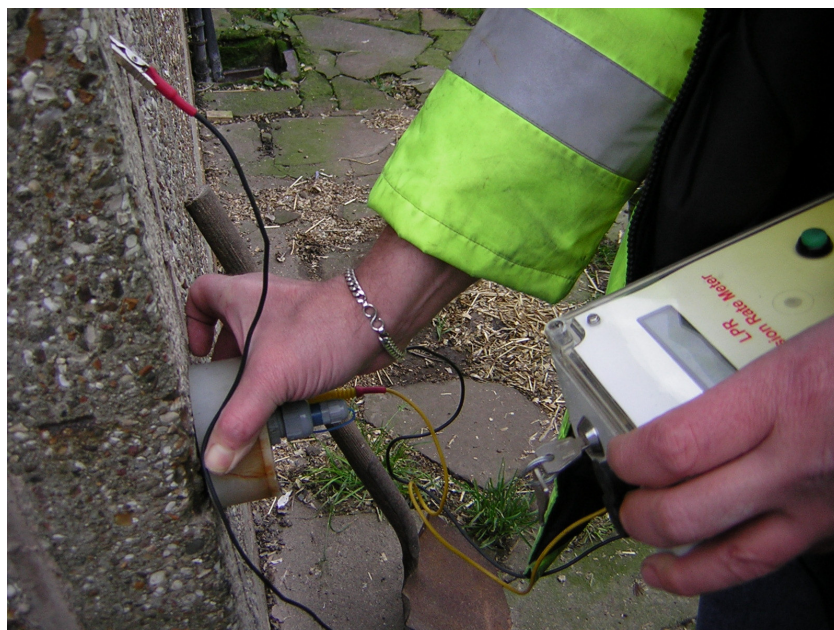
Linear Polarisation was undertaken in three locations on all void properties listed in Section 2.2, namely the corner post, lintel and wall panel. The tests indicated that the embedded reinforcement is in reasonable condition and that the rate of corrosion is in the region of 0.1mm per year, which is considered to be low.

Photograph 4 – Linear Polarisation Corrosion Rate Monitoring
