# June 2009 Floods

## Flood Investigations Final Report

**Produced by: Streetpride Drainage Team,  
Environment & Development Services**

**Date: April 2010**

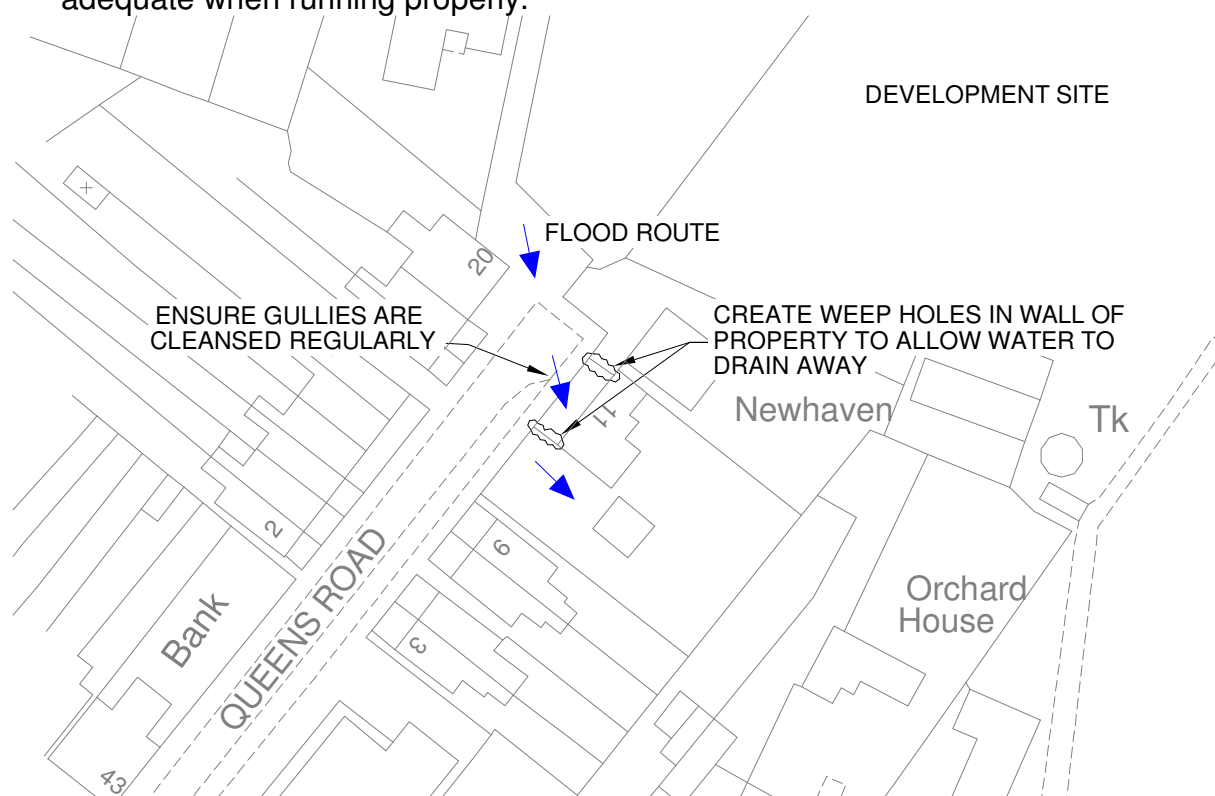
- Inspections, a survey of the existing drainage, level surveys and interviews with residents have been carried out.
- A resident said that the water runs from the path adjacent to 22 Queens Road, then over the gully located in the pathway and across the road toward no. 11.
- At the time of the event the gully outside number 11 was not taking any flow, however, some of the water was directed toward the next gully down, which was working and accepted the additional water, which indicates the system is adequate when running properly.

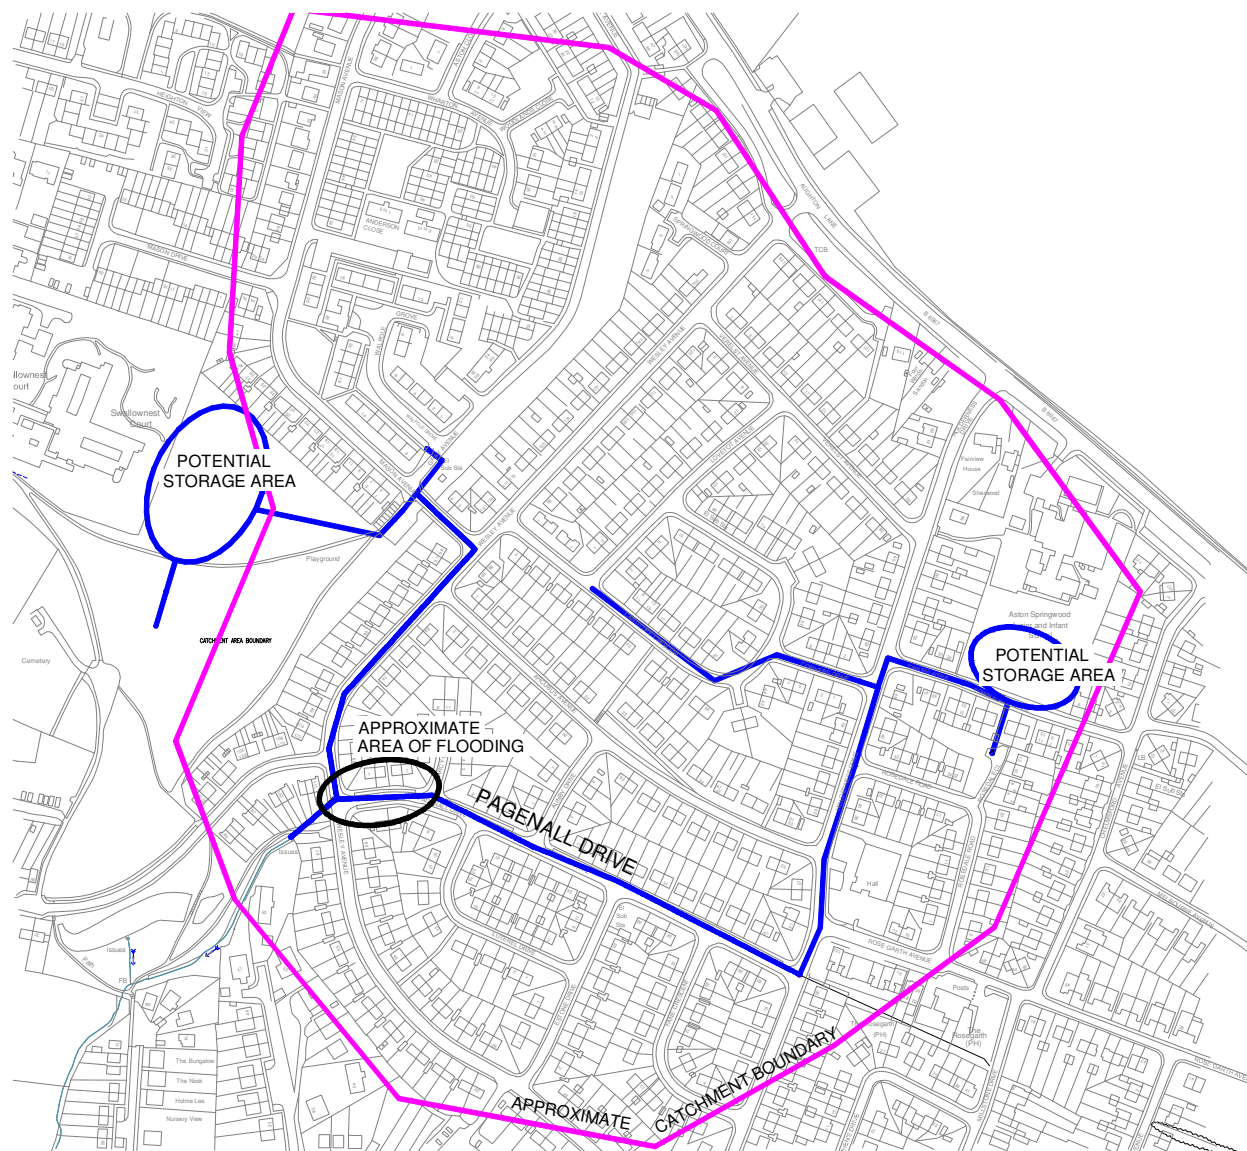
- The initial survey work, including surveys of flooded properties, has been carried out and some of the affected residents have been interviewed.
- This area is among those where it has been determined that the public sewers are fundamental to the effectiveness of the drainage system. The effects of possible works on other areas which drain towards Pagenall Drive have been considered.

Calculations suggest that the existing drainage system is sufficient to cope with a storm with a return period of in excess of 30 years, the usual design criterion, so it is unlikely that the public sewer, which is the responsibility of Yorkshire Water, will be improved. Further detailed analysis of the existing drainage system by Yorkshire Water would be required to definitively determine the capacity of the existing network. CCTV surveys of the public sewers have been carried out by Yorkshire Water and have shown that the sewers are generally in good condition and are running clear.

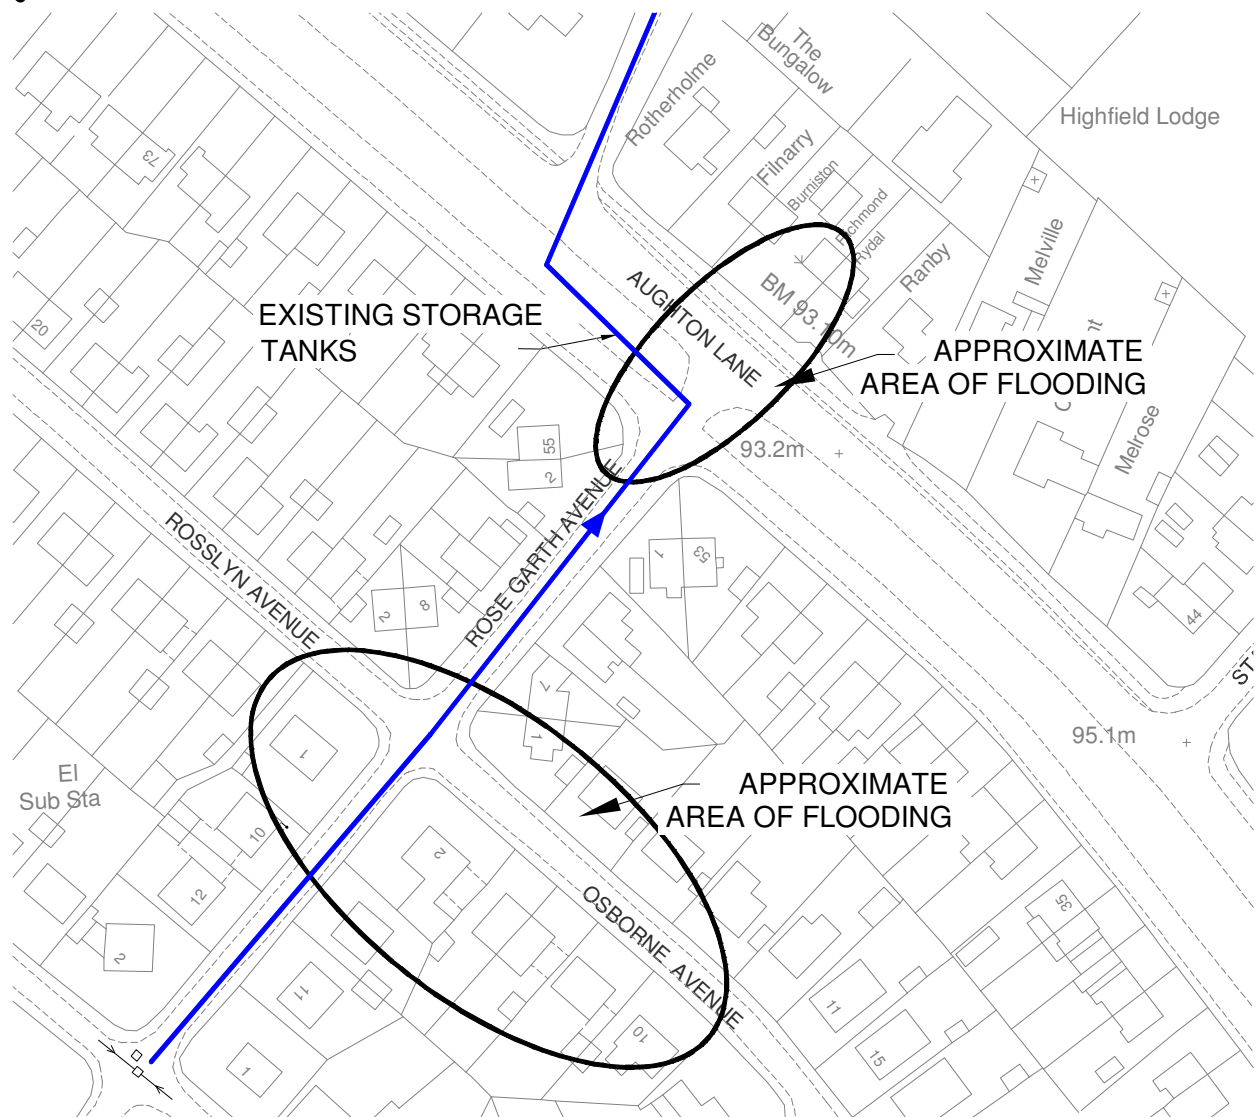
Flooding of Aughton Lane causes water to runoff the highway into the garden and garage of "Richmond".

- Inspections, a survey of the existing drainage, level surveys and interviews with residents have been carried out.
- Drawings showing the drainage constructed when the properties were built and the more recent highway drainage improvements were obtained.
-

Possible solutions for this area involve either preventing surface flooding from occurring by increasing the size of the existing drainage system, constructing additional drainage, creating storage for the flood water or reducing the impact of surface water flooding by providing property level flood protection and using flood resilient construction.

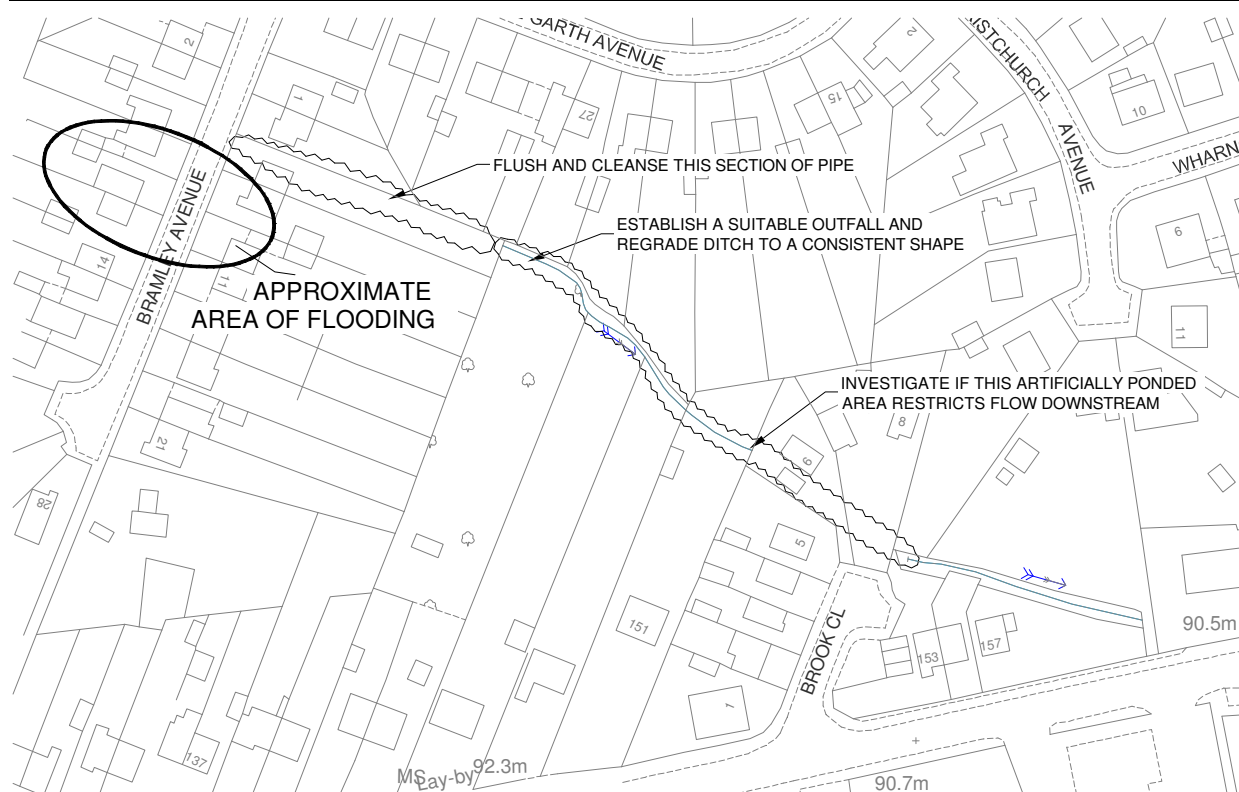
- Inspections, a survey of the existing drainage, level surveys and interviews with residents have been carried out.
- Gullies outside 52-58 Millstone Drive have been dye tested to prove the suspected connection to the west (via the network that runs behind The Rosegarth public house), between the systems in Millstone Drive and Pagenall Drive.
- The system on Bramley Avenue was flushed and dye tested and found to flow to the east along the rear of properties Worksop Road, under Brook Close and then across Worksop Road down into The Chase.
- This area is among those where it has been determined that the public sewers are fundamental to the effectiveness of the drainage system.
- A CCTV survey of the drainage system has been completed.

The culvert underneath Brook Close requires further investigation as to its current condition. Access would require the cooperation of land owners.

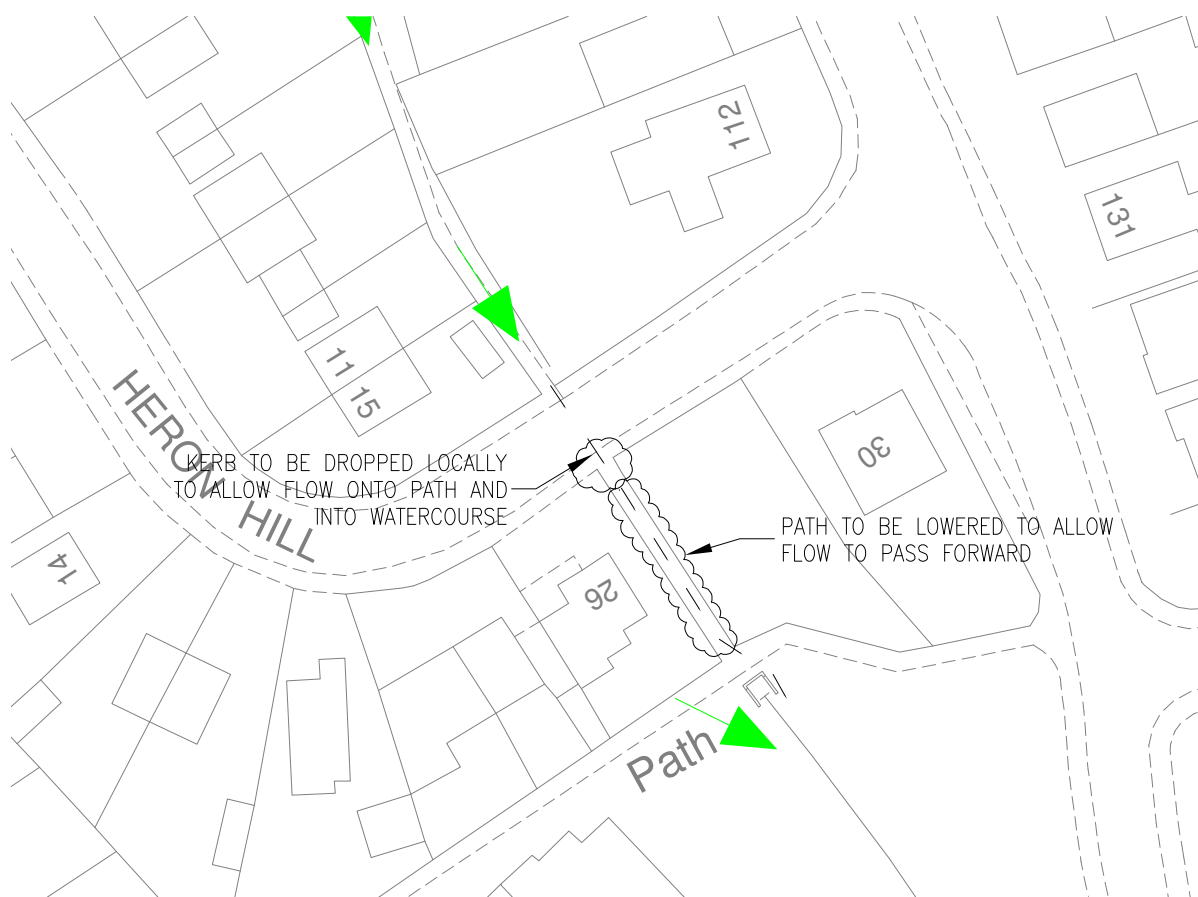
- Detailed topographical survey and dye testing has been undertaken.
- A significant amount of investigation has been undertaken to establish the contributions from upstream catchments and their exact points of connection.
- Investigation into providing flood storage areas upstream in the open land and provision of an emergency overland flood routes is ongoing.

Aston Parish Council employed contractors to clean and remove debris from the channel at the recreation ground, during November 2009.

A possible solution has been devised to help alleviate the flooding at numbers 22, 24, and 26 Heron Hill:

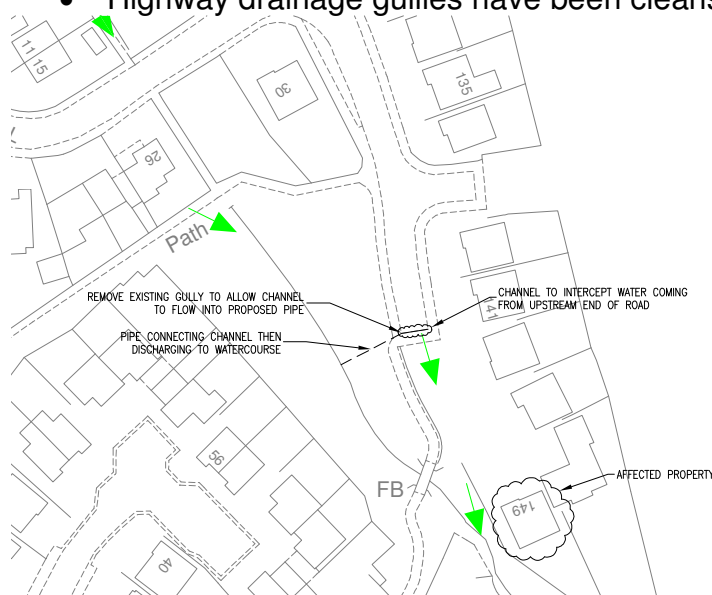
- Inspections, a survey of the existing drainage, level surveys and interviews with residents have been carried out.
- Highway drainage gullies have been cleansed

There is no indication that the sewers are not suitable for the usual criterion for design of a 30 year return period. It is inevitable that when this is exceeded, as it was in June 2009, flood water will overflow from the sewer system. The ground levels currently allow flood water to drain toward the properties. Minor alterations to ground levels in the front garden could divert this water away from the properties on the rare occasions when the sewers are overloaded.

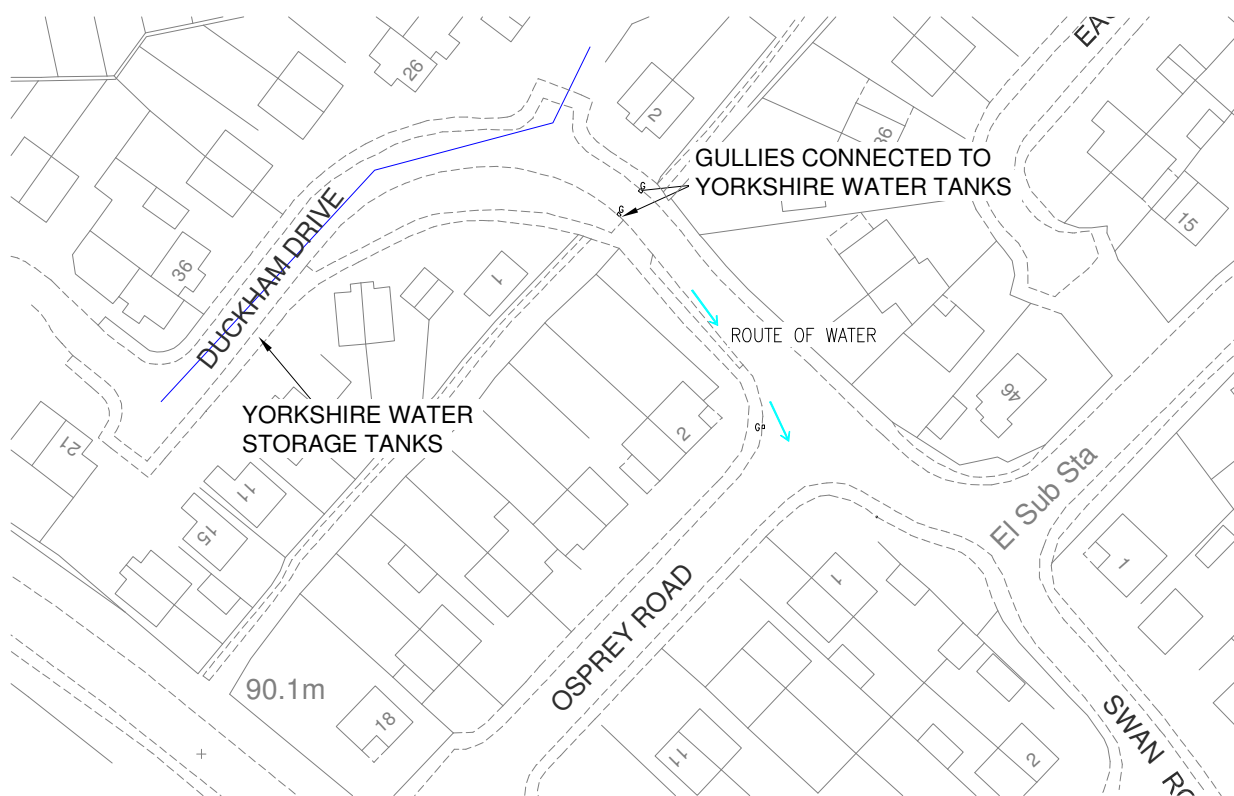
- Inspections, a survey of the existing drainage, level surveys and interviews with residents have been carried out.
- Yorkshire Water has checked the public sewers in the area and has found no problems.

A non return valve could be fitted to the connection to the road gully opposite no.2 Duckham Drive. Overflow from the tank would then first occur from the gully on the opposite side of the carriageway, away from Osprey Road.

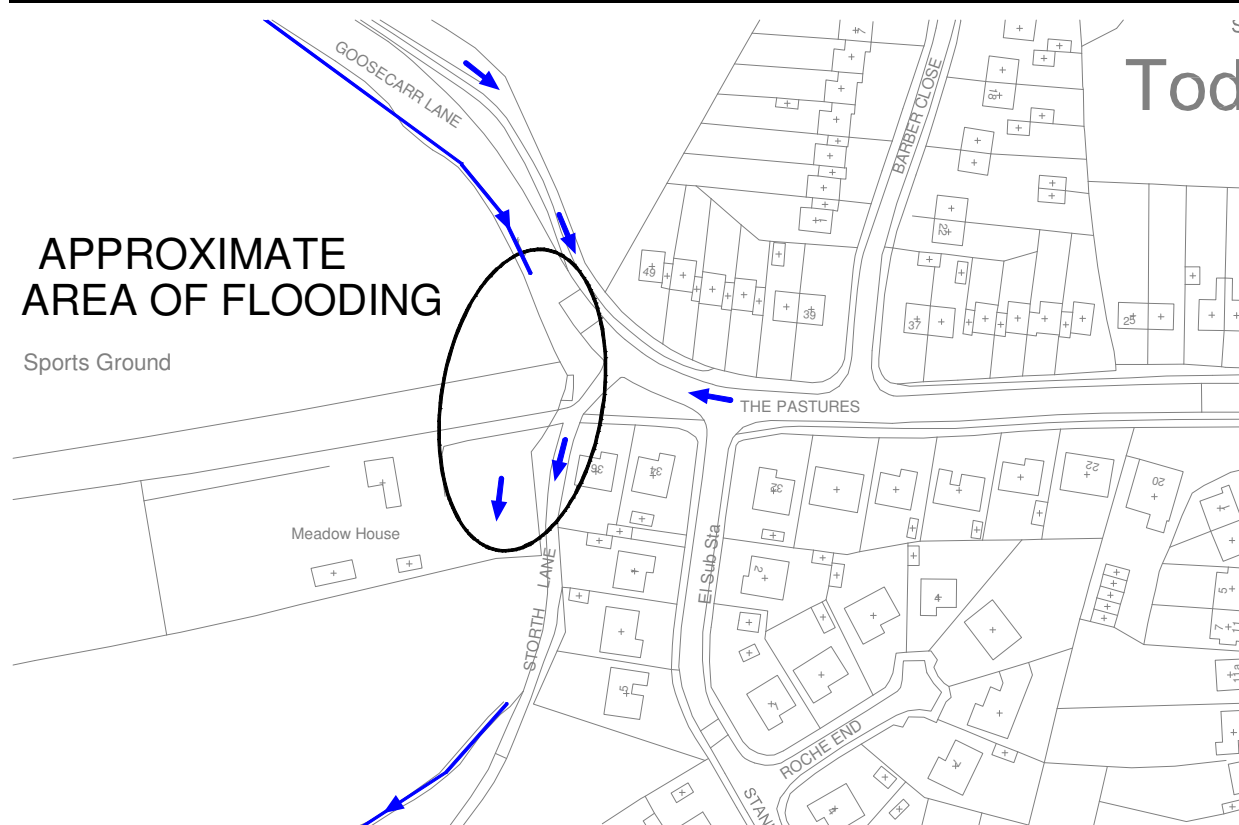
- Inspections, a survey of the existing drainage, level surveys and interviews with residents have been carried out. Photographs of previous flooding have been obtained.
- The culvert inlet has been cleared and it has been added to a regular maintenance schedule.
- A surface water drain running from the verge adjacent to no 49 has been discovered and the previously buried inlet has been uncovered.

The flooding which affects Goose Carr Lane is predominantly due to runoff from adjacent agricultural land. There are a number of piped sections of drains which were unrecorded and therefore were not regularly maintained. Blockages in these pipes caused water to drain onto the carriageway of Goose Carr Lane and there was insufficient drainage of the carriageway to effectively drain this water back into the existing drainage systems. The culvert inlet on the west side of Goose Carr Lane has now been added to the Council's schedule for regular inspection and maintenance.

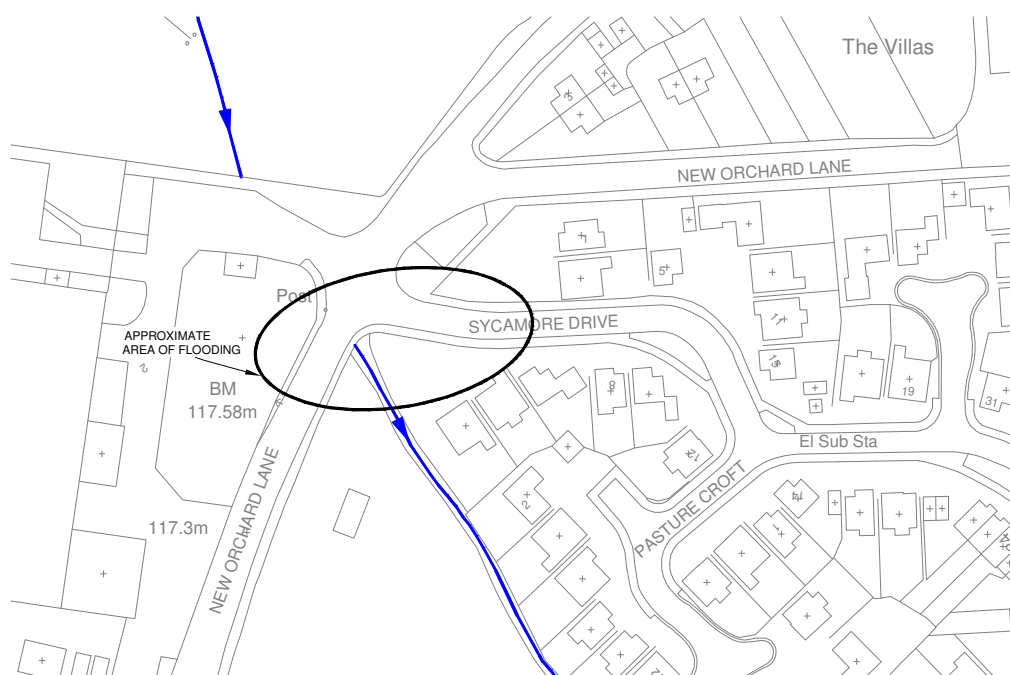
- Inspections, a survey of the existing drainage, level surveys and interviews with residents have been carried out.

The watercourse downstream of the culvert appears to have sufficient capacity. Maintenance of the culvert is required by the riparian owners, in this case the adjacent factory and the Council.

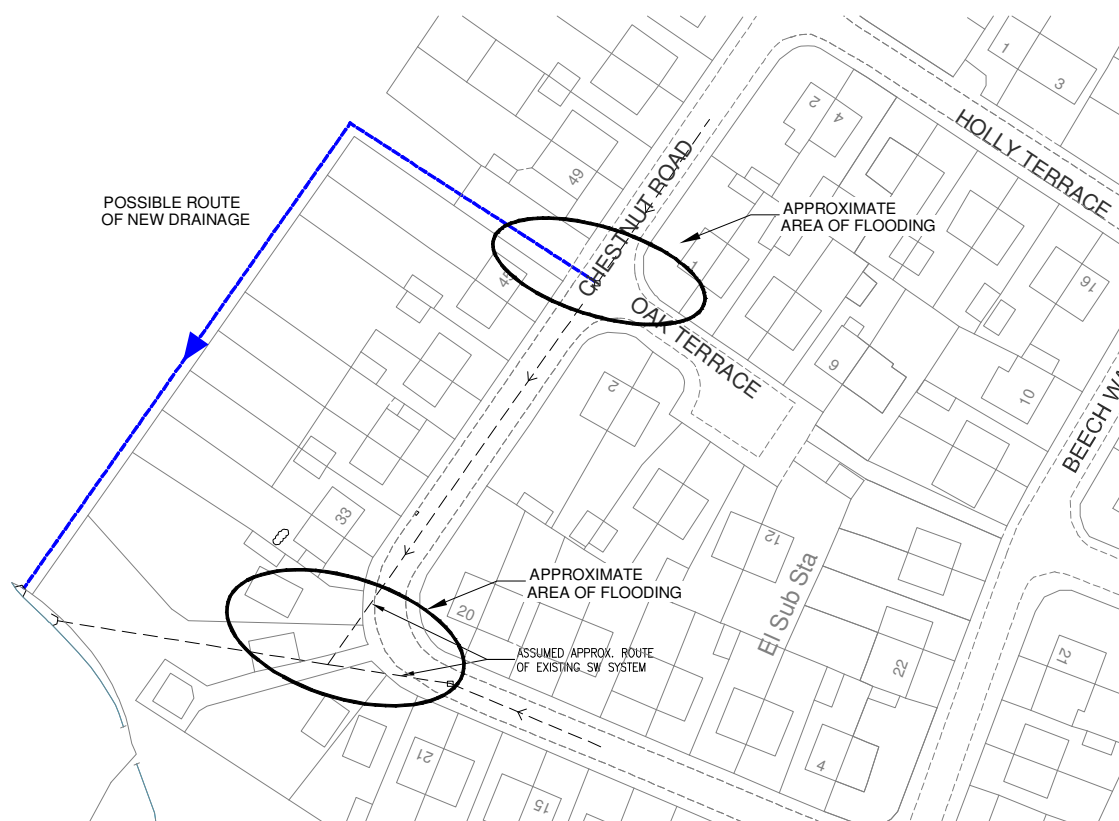
- Inspections, a survey of the existing drainage, level surveys and interviews with residents have been carried out.
- Water cannot move across the front of number 31 as the driveway is sealed in by a boundary wall and the natural escape route through the garage area is blocked by a door – the owner did however say that when the water builds up he stands at the back of the garage area and holds the door open to let the water escape.
- Following earlier flooding a hydraulic model was constructed which confirmed that the highway drainage system has insufficient capacity.

With the co-operation of the landowner, a new highway drain could be constructed through the land between 45 and 49 used as access to the field, then down the edge of the field to discharge to the watercourse at the rear of number 27. Preliminary discussions with the landowner have taken place.

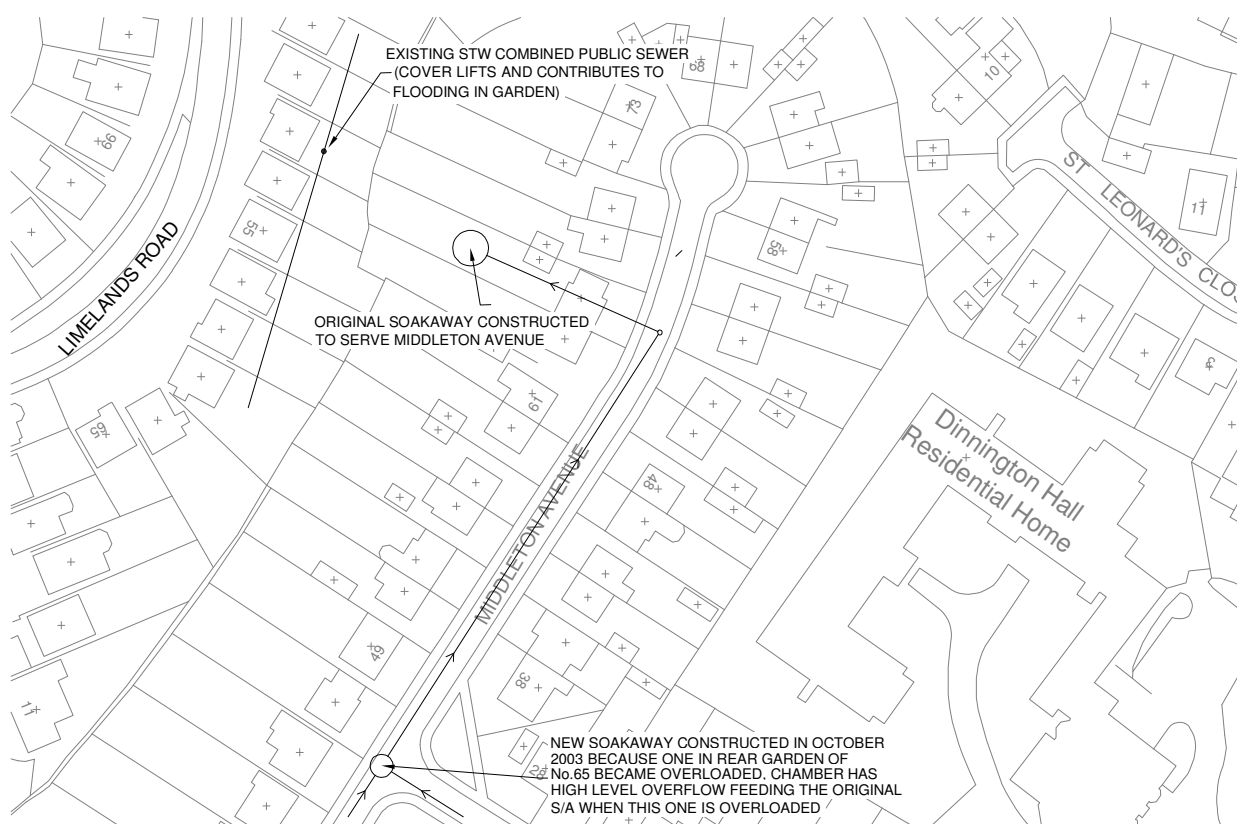
- Inspections, a survey of the existing drainage, level surveys and interviews with residents have been carried out.

There are currently two soakaways in Middleton Avenue. The second soakaway was constructed to alleviate previous flooding and had been effective until June 2009. Soakaways become ineffective when the ground surrounding them becomes saturated. The operation of the public sewer is therefore critical during very heavy rainfall. It is unlikely that Severn Trent Water would take action to improve the sewer unless properties were flooded internally. All incidents of flooding from the sewer should be reported to them as the frequency and severity of flooding as reported to them are critical factors in prioritising works.
