**JOINT MEETING - CABINET MEMBER FOR ECONOMIC DEVELOPMENT,
PLANNING AND TRANSPORTATION AND THE CABINET MEMBER FOR
STREETPRIDE SERVICES**

- to report performance statistics for quarter 4.
5. June 2009 Flooding Progress Report. (copy attached) (Pages 23 - 83)
Graham Kaye, Principal Engineer, to report.

- to present the final report on the flash flooding event of June 2009 together with actions taken by the Council to date and proposals to further improve resilience against future flooding.

PROGRESS REPORT OF INVESTIGATIONS INTO THE CAUSES OF THE FLOODING

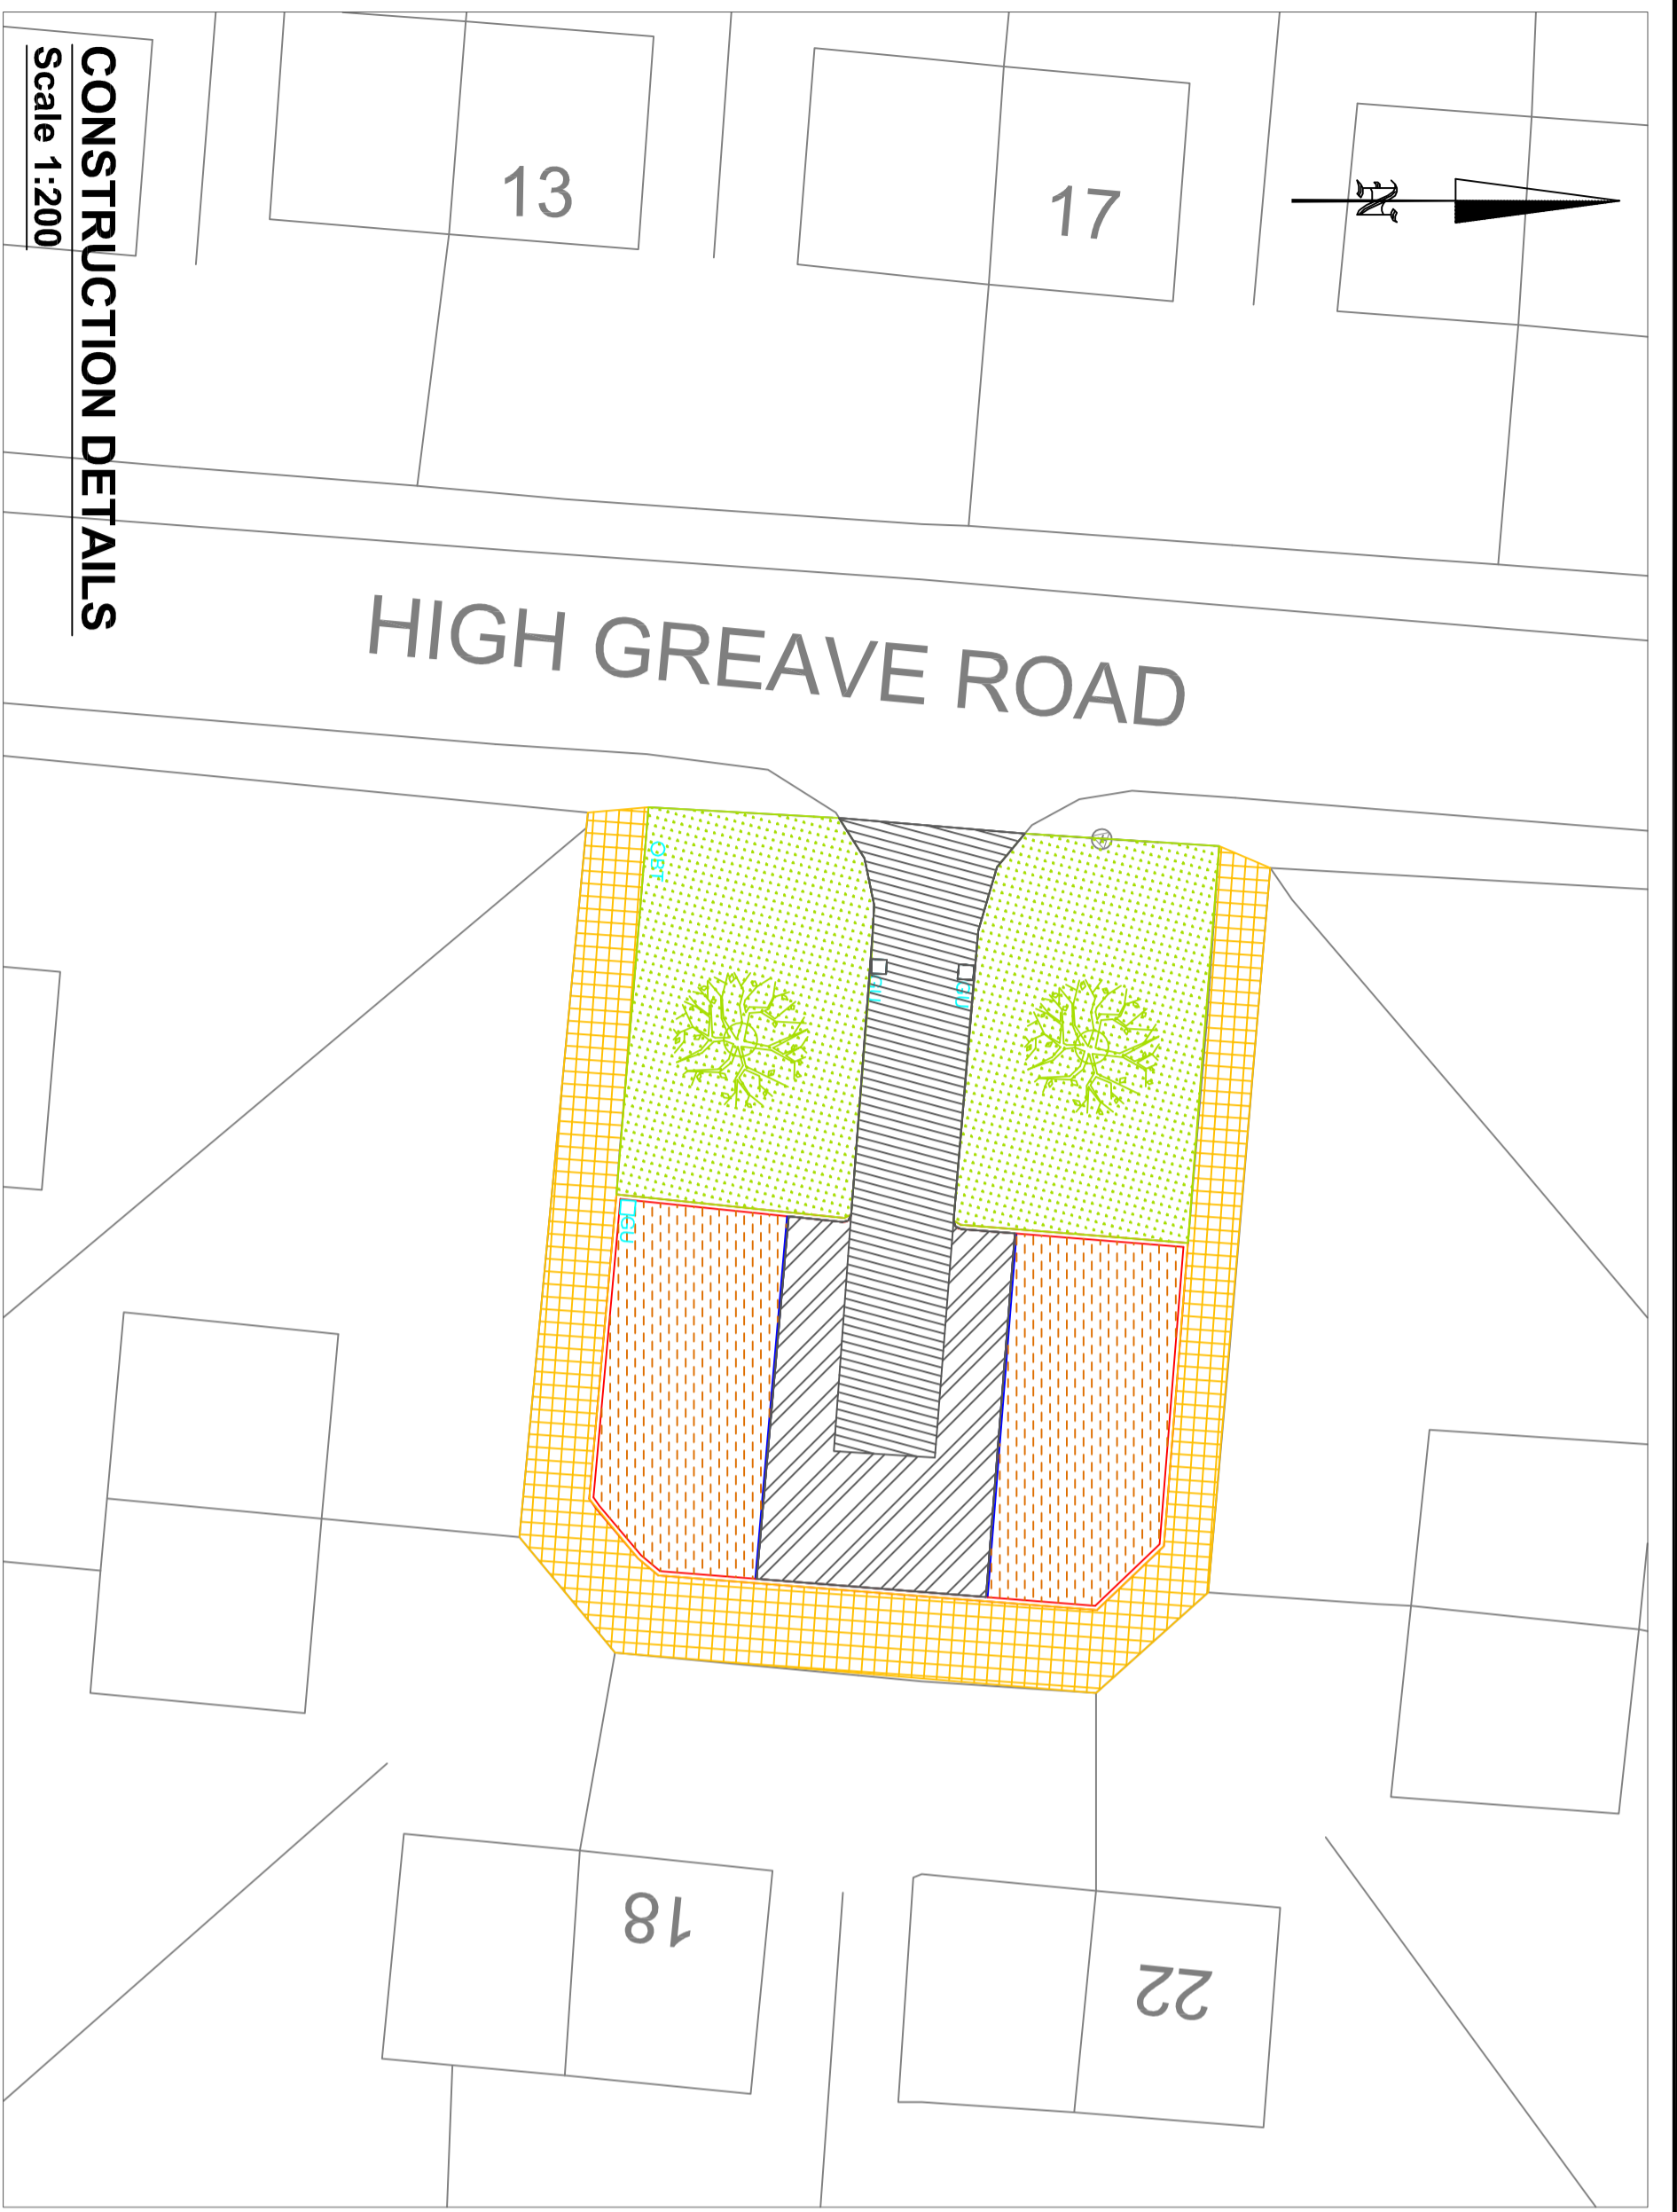
CONSTRUCTION DETAILS
Scale 1:200

**Footway Construction**
20mm Thick Dense Wearing Course
50mm Thick Dense Macadam Binder Course
100mm Thick Type 1 Sub Base
-

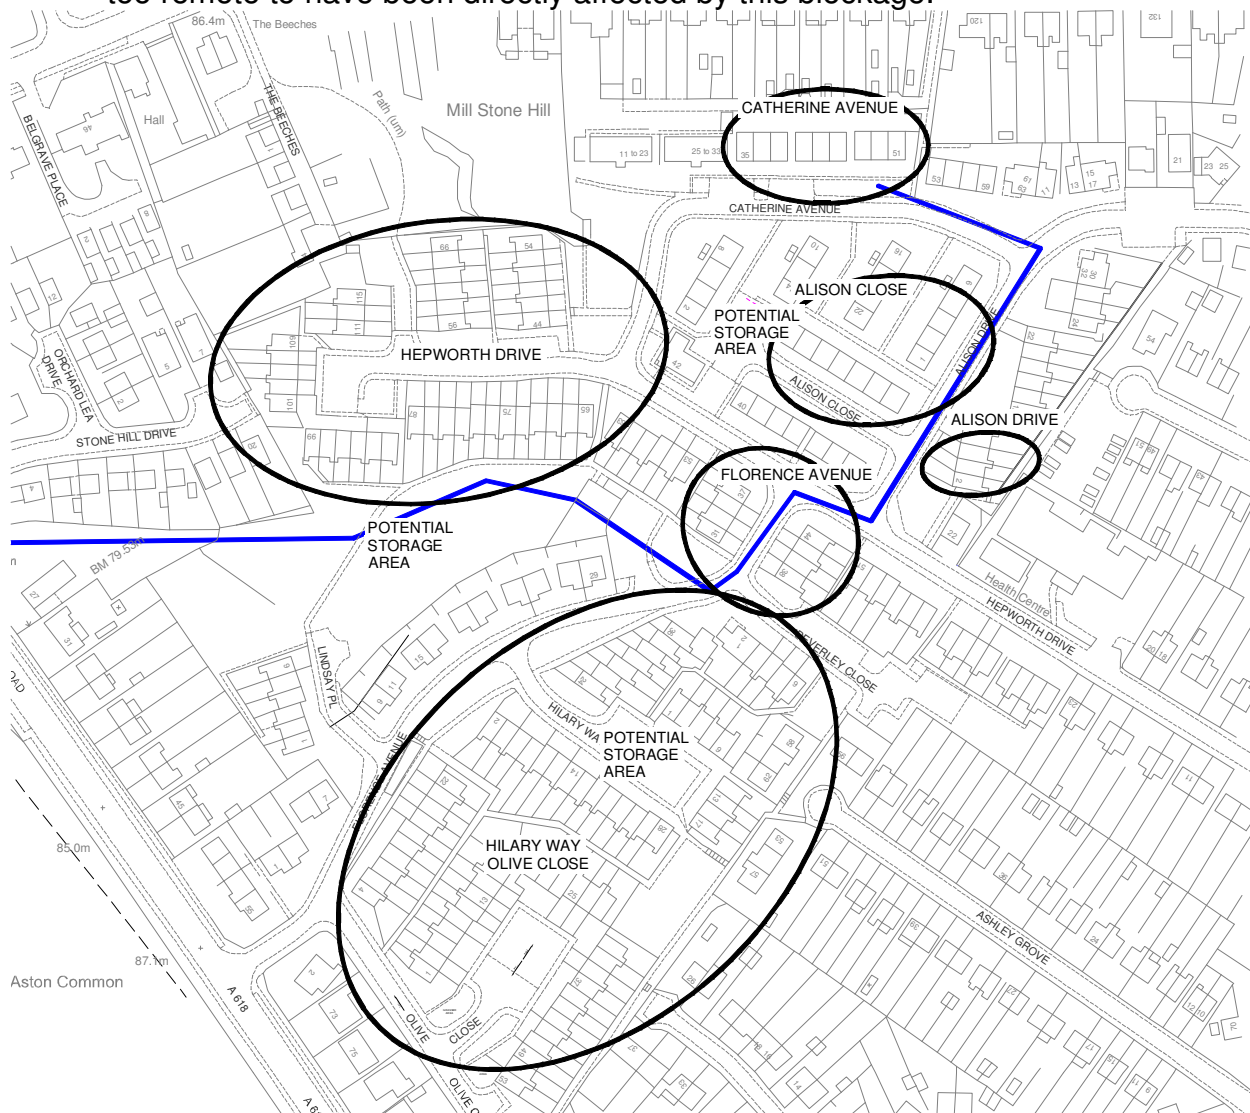
- Inspections, a survey of the existing drainage, level surveys and interviews with residents have been carried out.
- The critical surface water sewers have been identified and CCTV surveys of these sewers have been completed.
- A manhole in the open land between Hepworth Drive Avenue and Florence Avenue was found to contain a large amount of debris, causing a major disruption to flows. Large items found in the manhole suggest that many items were deliberately put into the manhole. This manhole has been cleared and the system is now running freely. Most of the flooded properties drain through this manhole, but many are too remote to have been directly affected by this blockage.

Many of the blocks of properties on this estate have gardens at either the front or the rear which slope towards the dwellings. During extreme rainfall events, the drainage around the properties is inadequate. The water then starts to pond and cannot drain around the properties because outbuildings, fences or walls obstruct any possible overland drainage routes. Preventing flooding of such properties can be achieved in 2 ways, that is diverting any overland flows away from the buildings, or ensuring that there is sufficient drainage to cope with everything which drains into the gardens. Installation of new drainage would require the cooperation of all the property owners affected and in some cases would involve the removal or alteration of outbuildings, fences or walls. Minor improvements to some gardens at modest cost could reduce flood risk for some of the properties.
