## Petition Temple Crescent, Bramley

### Appendix 1

### Identification, Categorising and Risk Assessment

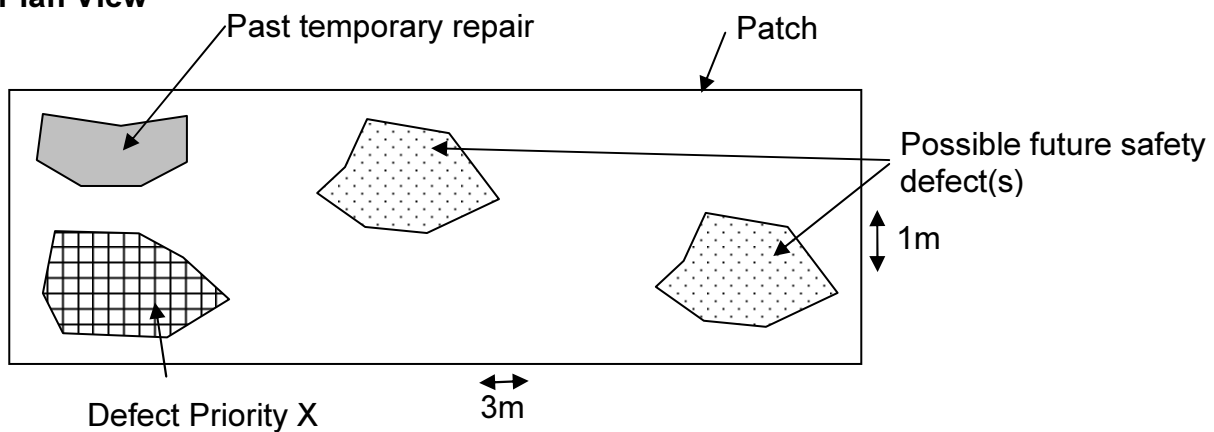
#### Plan View

All other defects will be placed in the new Priority X (48hrs) category, the close surrounding area need to be assessed. The methodology is to include any past temporary repairs and any other defects that could become hazardous in the near future. The completed repair should be of a "table top" size.

To reduce the number of safety defects appearing close to an existing safety repair, it is proposed to expand the area immediately adjacent to an identified safety defect to include future potential safety defects.

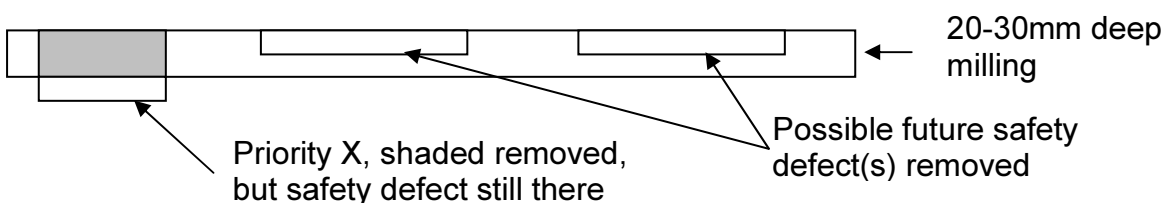
#### After milling

**PX removed**

Patch to be repaired within 5 days

Improvements in the quality of the repairs are also required and the "Multihog" will provide a quick and efficient method of excavating the highway to accept better quality material and repair methods. This will significantly reduce the number of repeat safety repairs at a location.
